REPORT NO. 1143

BOMBS AND ASSOCIATED COMPONENTS

-----  
COLD WEATHER TESTING OF BOMB,  
EX 14 MOD 0 (FIRE-1000 LBS)

FINAL Report

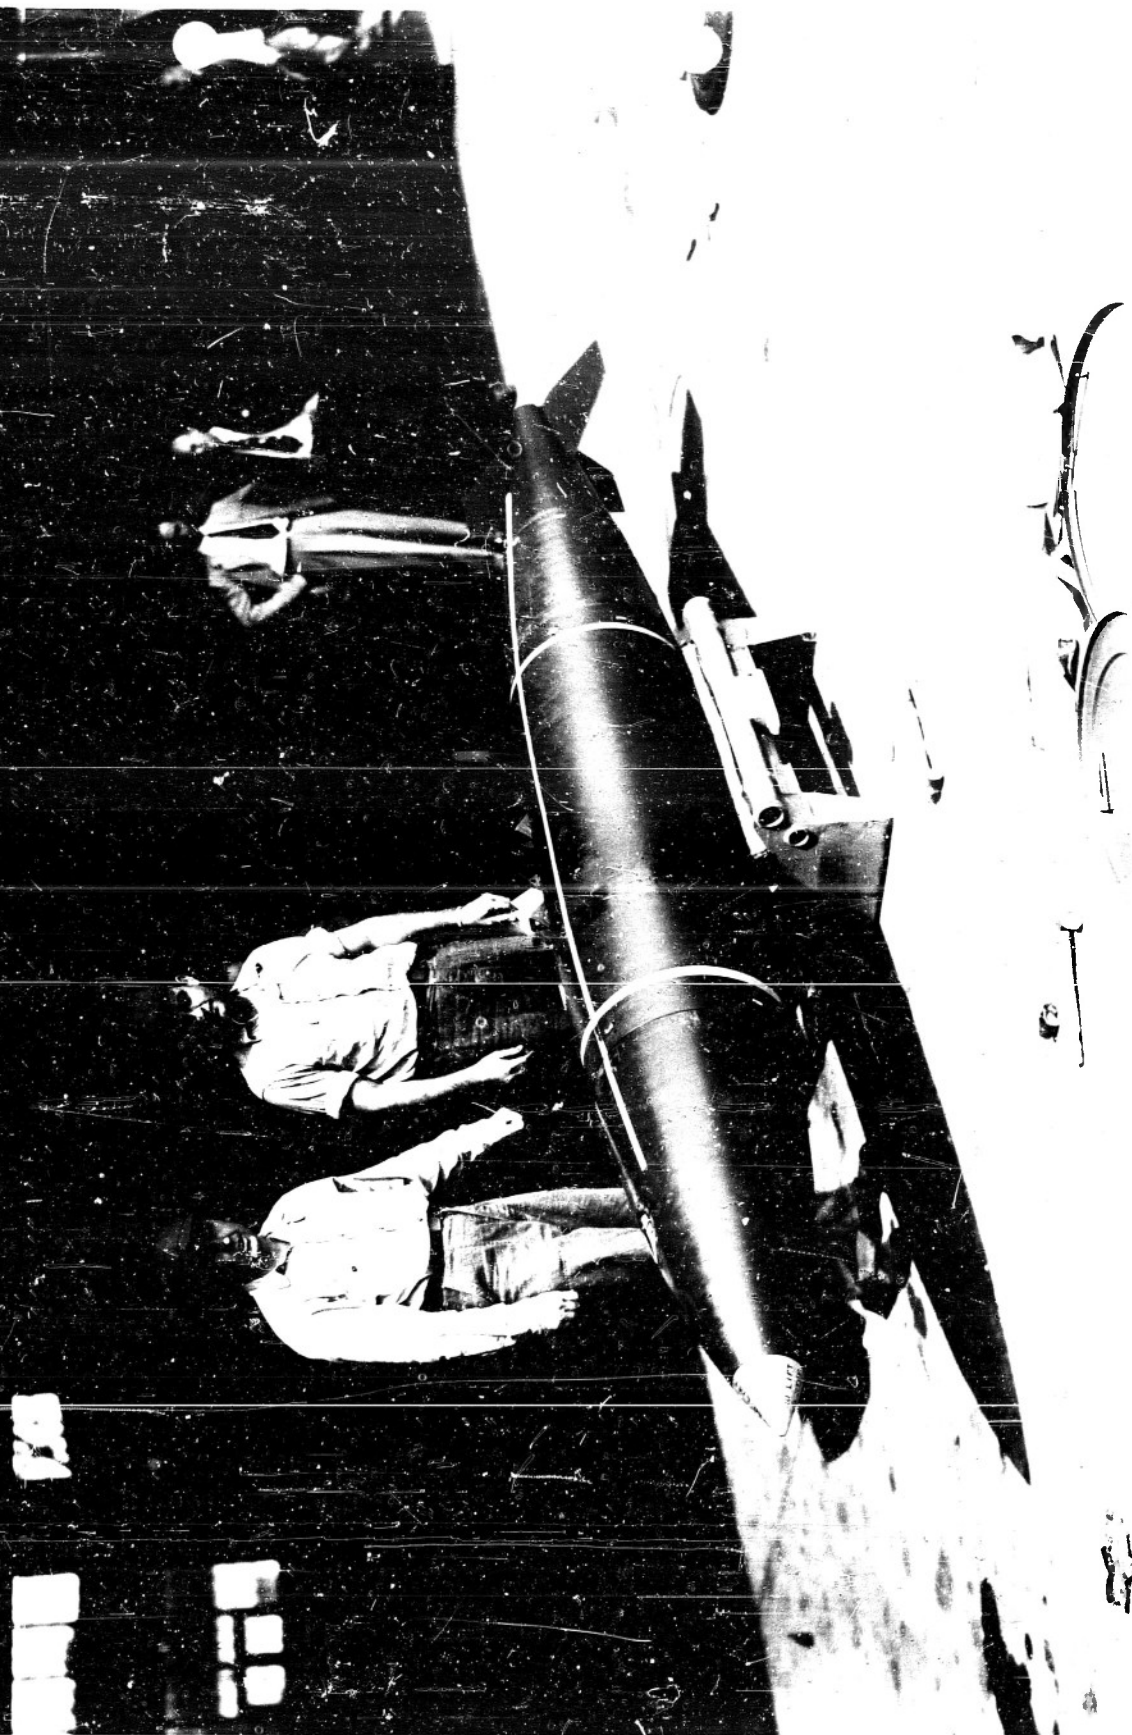
The Ex 14 Mod O Fire Bomb used for this test was similar to the bomb used and reported in reference (c), with the exception that removable lock pins were supplied and used. It was originally intended that these lock pins would allow the bomb to be disassembled and returned to the manufacturer. Figure 1 is a view of the bomb in its collapsed shipping configuration. Figure 2 is an assembled view of the bomb.

NP9-60454  
Bomb, Ex 14 Mod 0 (Fire-1000 lbs.) in an assembled configuration.  
Figure 2
